5 Spurn Peninsula

Possible Evolution of Spurn Peninsula

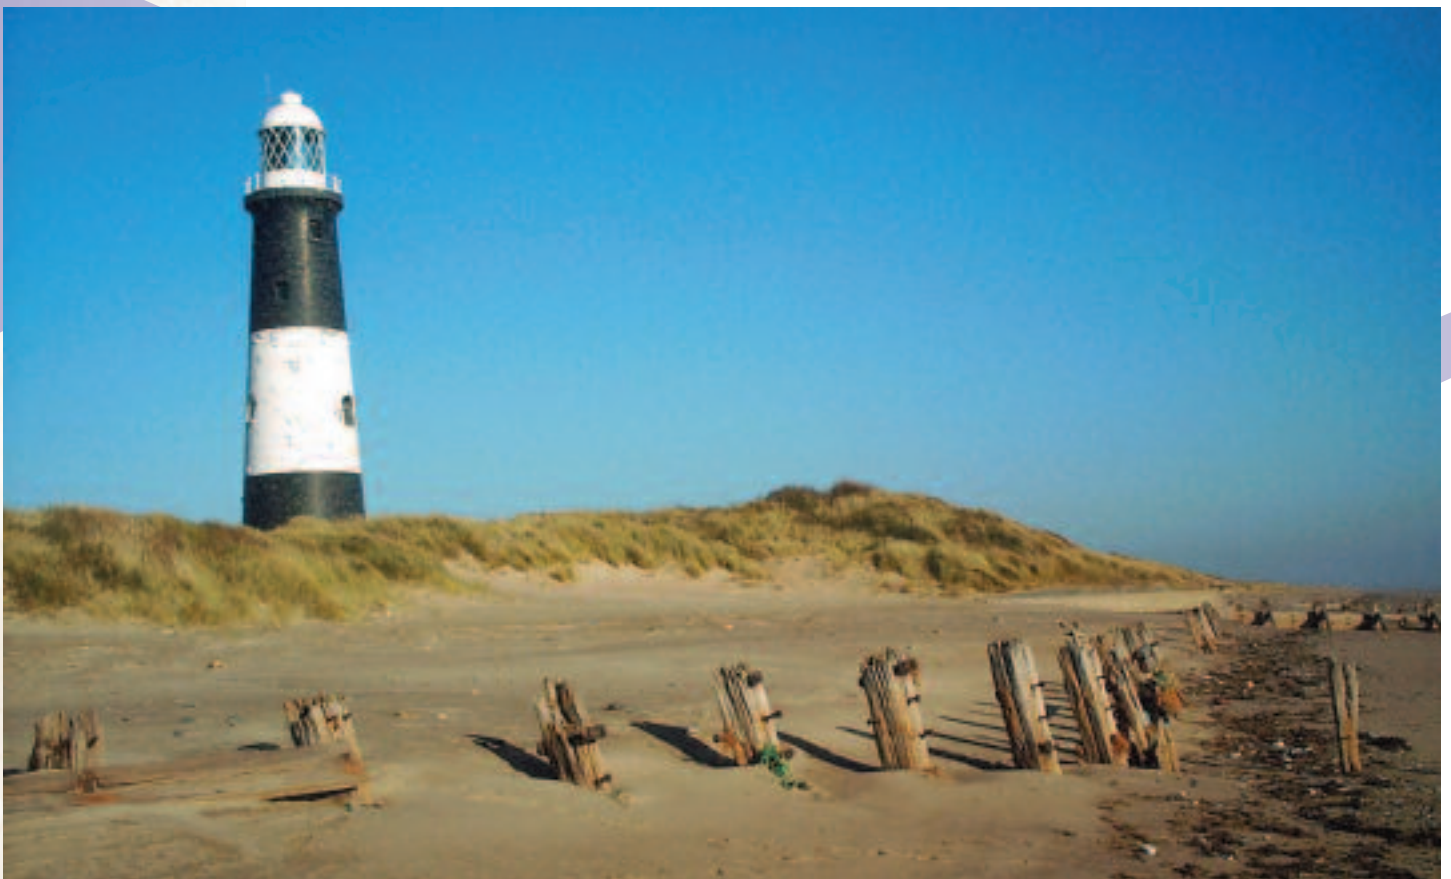
Interestingly the last cycle ended in the mid 1800's a time when erosion of the peninsula prompted the construction of extensive coast protection works. It is likely that had these defences not been built then Spurn peninsula as we know it would have been washed away decades ago. Construction of the defences has however only delayed the inevitable, as in 1961 the decision was taken following escalating maintenance costs, to abandon the defences and allow the natural processes to take control once again.

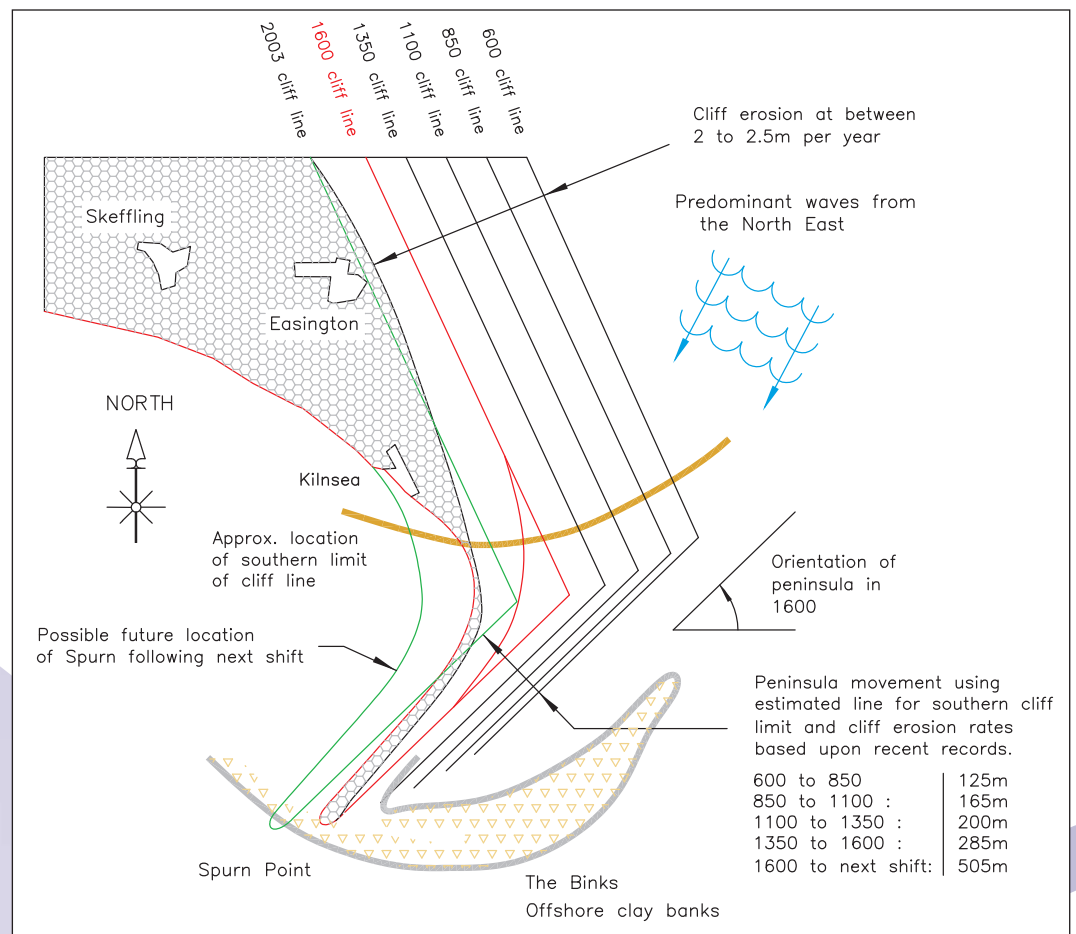
To estimate how far the peninsula is likely to move, a stable spit shape has been superimposed upon a series of historical cliff lines. Using the current cliff erosion rate of approximately 2 metres per year as a starting point the peninsula could move by as much as 500 metres with every formation. However due to the orientation of the peninsula in relation to the line of the southern edge of the cliffs this is likely to reduce to a few hundred metres. From this work it is then possible to forecast where the next spit is likely to form. Holding the peninsula in its current position has extended its life by some 150 years but during this time the cliffs to the north have continued to erode westward, the estimated movement has therefore increased to between 250 and 500 metres.

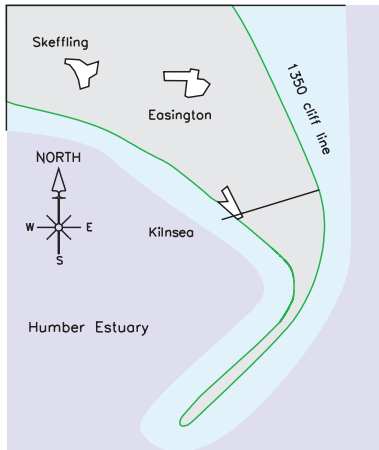
Date: 1350

Peninsula reformed following earlier breaches with its seaward edge aligned to suit the then current cliff line opposite Kilnsea.

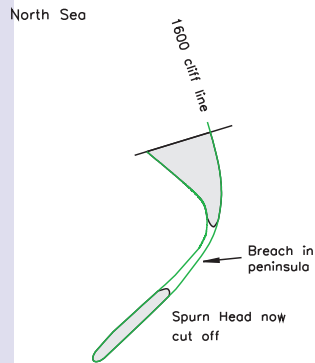
Date: 1600

Peninsula narrows to a point where breaches occur creating a new channel between the Humber and North Sea.

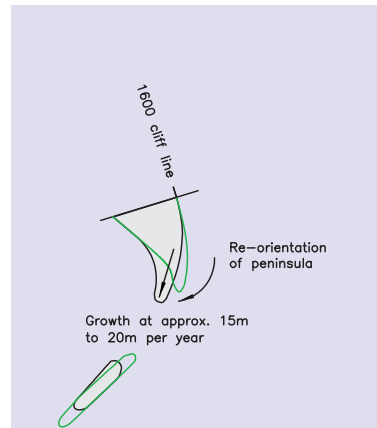
Date: 1600 - 1700

Breach in peninsula causes realignment of north end root as southerly deposition of sand starts to rebuild the peninsula in lee of the new cliff line.

Erosion gradually reduces the size of the southern island, gaining protection from the Binks it may have survived and rejoined the peninsula or been lost and reformed at a new location several hundred metres west.
